Pt and Hf Additions to NiAl Bond Coats and Their Effect on the Lifetime of Thermal Barrier Coatings

J.A Nesbitt¹, B. Gleeson², D. Sordelet² and C.A. Barrett¹

¹ NASA Glenn Research Center, Cleveland, OH 44135, USA ² DOE Ames Laboratory, Ames, IA 50011-3020, USA

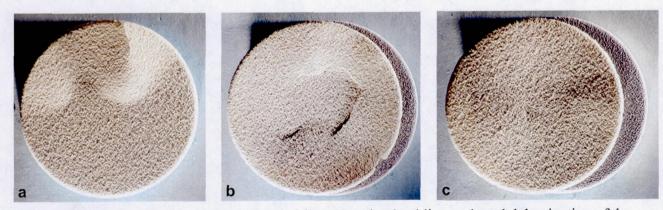
Examples of typical failure morphologies are shown in Fig 1. Fig 1a shows a typical delamination which usually initiated at an edge. Figs 1b,c show that the delaminations can spread rapidly until the entire top coat delaminates from the bond coat. The cycles to failure are shown in Fig 2. As shown, the TBC lifetimes for five of the bond coats are very similar with shorter lifetimes for Ni50Al14PtZr and Ni50AlZr. It is surprising that the binary Ni50Al bond coat shows an average TBC lifetime somewhat greater than that for the bond coats containing Pt or reactive elements.

Figure 1 Macrographs of tested samples at failure showing buckling and total delamination of the ceramic top coat. (a) Ni50Al, 160 cycles, (b) Ni50Al7Pt, 160 cycles, (c) Ni50Al14PtZr, 120 cycles.
